The following photos exhibit the need for this project. Over the last several decades, the District has increasingly repaired this siphon. This is attributed to the siphon far exceeding the intended design life

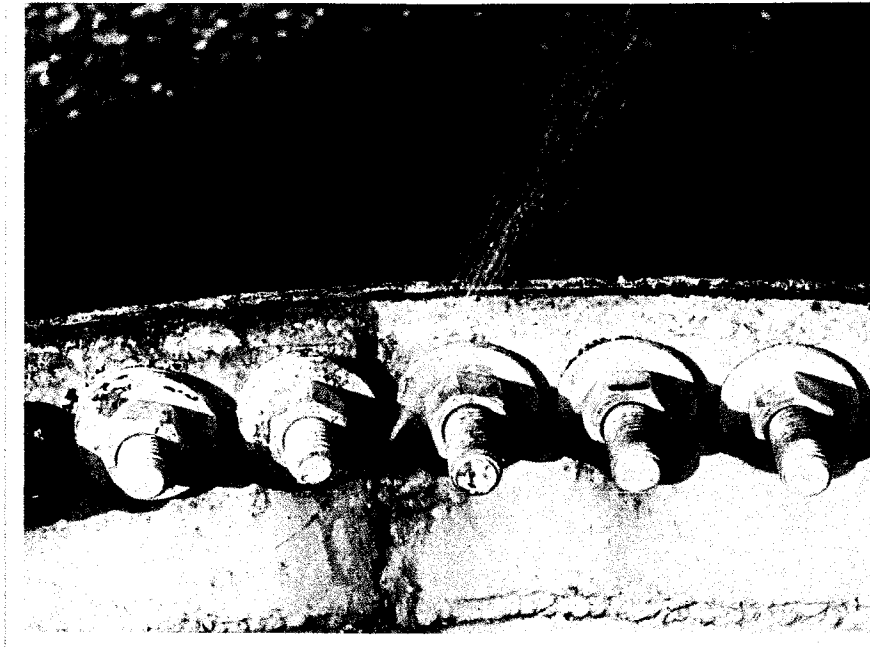
Photo 1 – Leaking expansion joint

Siphon 1 has several bellow style expansion joints throughout the siphon. This expansion joints leak resulting in the loss of water and continual maintenance by the District.

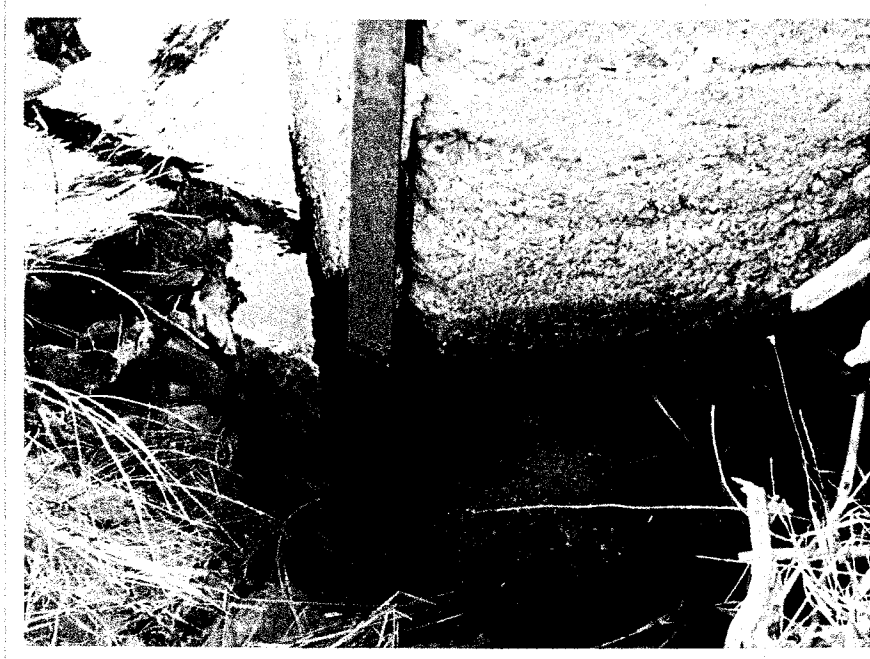
Photo 2 – Seepage around pipe support

Standing water around the concrete pipe support is evidence of water loss from the siphon.

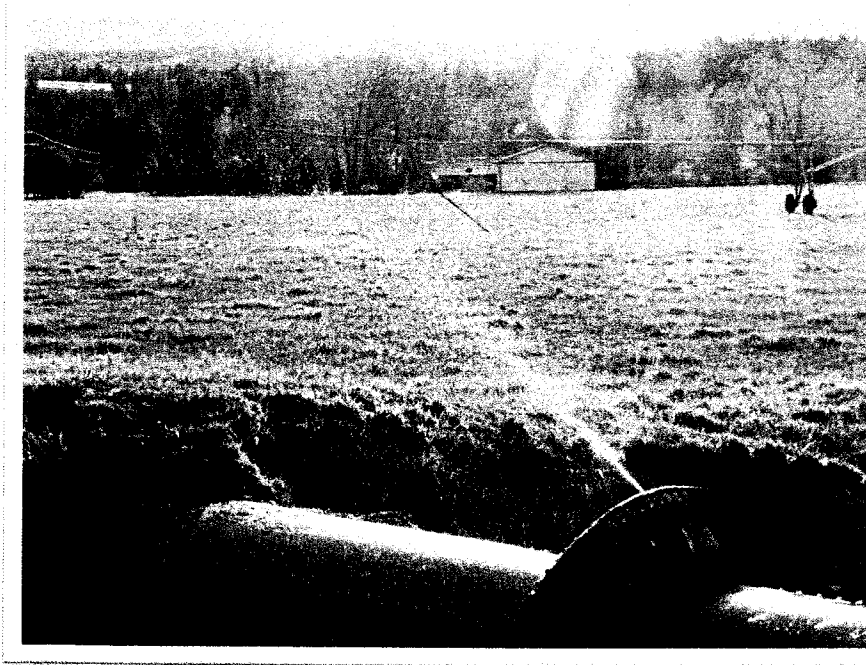
Photo 3 – Leaking expansion joint in field

This photo depicts a leak in one of the several expansion joints in the siphon. The location of the leaks varies from season to season and the maintenance is continual.

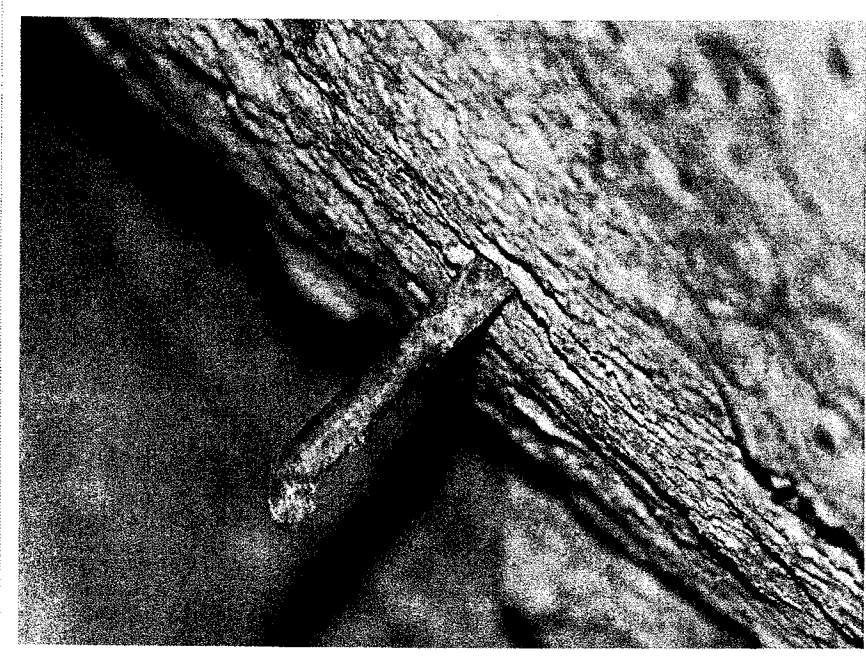
Photo 4 – Leaking expansion joint

The District uses nails and J-B Weld to repair leaks in the pipe. This type of repair is not ideal considering the high flows and high pressures in this pipe.

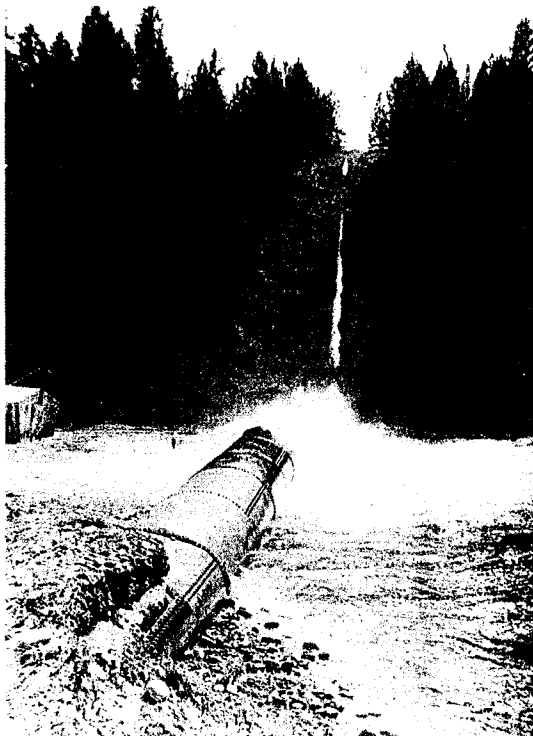
Photo 6 – Failure in 1979

The siphon failed in 1979. Only a small portion of pipe was replaced and much of the outdated pipe is still in use.

The break in the Big Bend main pipe kept at the head of a pipeline for over 100 years that dissects a steep slope, caused a terrible loss below the water. The pipe was not the heavy gauge pipe into a random shape and pulled apart at its north end of head. (Photo by Mark Scharfendick)

Figure 33. A blowout in August, 1979 (Ravalli Republic photo, Ravalli County Museum).
